Manhole Inspection Summary

Manhole # S63G__014MH

Location Address: **5100 Mason Lord Dr.**

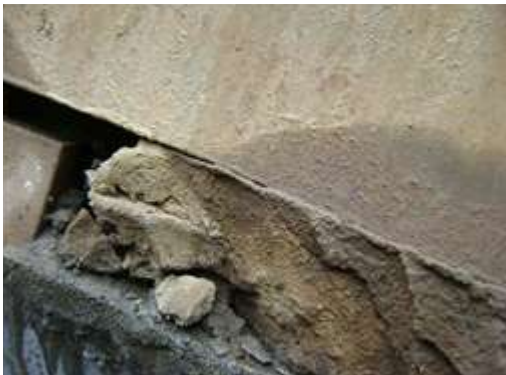
Defect 3

Condition: ☐ Sound ☐ Cracked ☐ Root Intrusion ☒ **Loose Brick** ☒ **Deteriorated**

loose bricks and mortar at frame seal

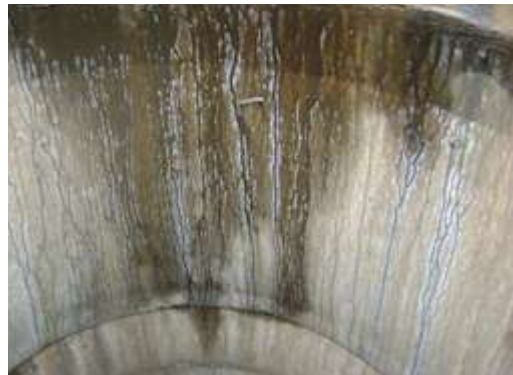
Defect 1

infiltration on chimney and barrel wall

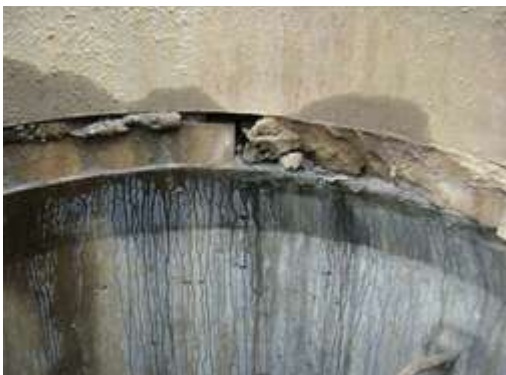
Defect 4

infiltration at chimney

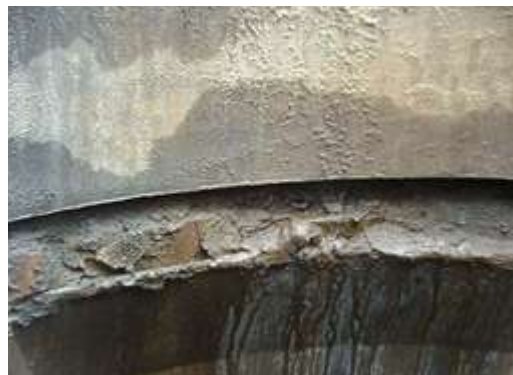
Defect 2

gap at frame seal

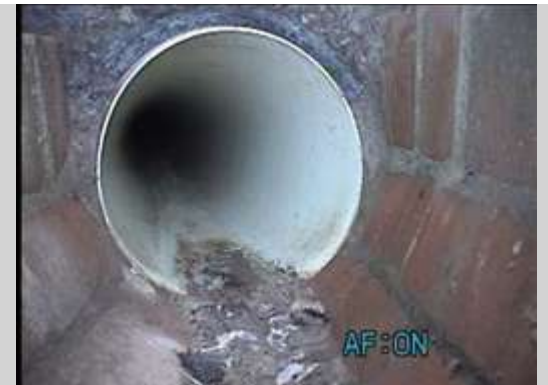
3 O'Clock Inflow

Pipe Height: **8.4** (in.) Rod and Bar (Angled)
Pipe Material: **PVC** ☐ Pipe Lined
Invert Depth: **11.17** (ft.) Flow Characteristics: **Slow**
Deposits: ☐ None ☐ Mud ☐ Sludge ☒ Debris ☐ Grease
Silt Depth: **0.25** (in.) Deposits Extent: **Light**
Infiltration: **None** Pipe Seal Cond: **Sound**

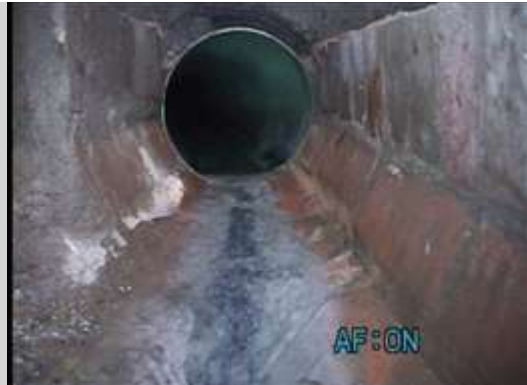
6 O'Clock Inflow

Deposits: ☐ None ☐ Mud ☐ Sludge ☐ Debris ☒ **Grease**

Silt Depth: **0.125** (in.) Deposits Extent: **Light**
